08FTM18

Gear Corrosion During the Manufacturing Process

By O. El-Saeed and G. Sroka,
REM Chemicals, Inc. and
G. Blake, Rolls-Royce
Corporation

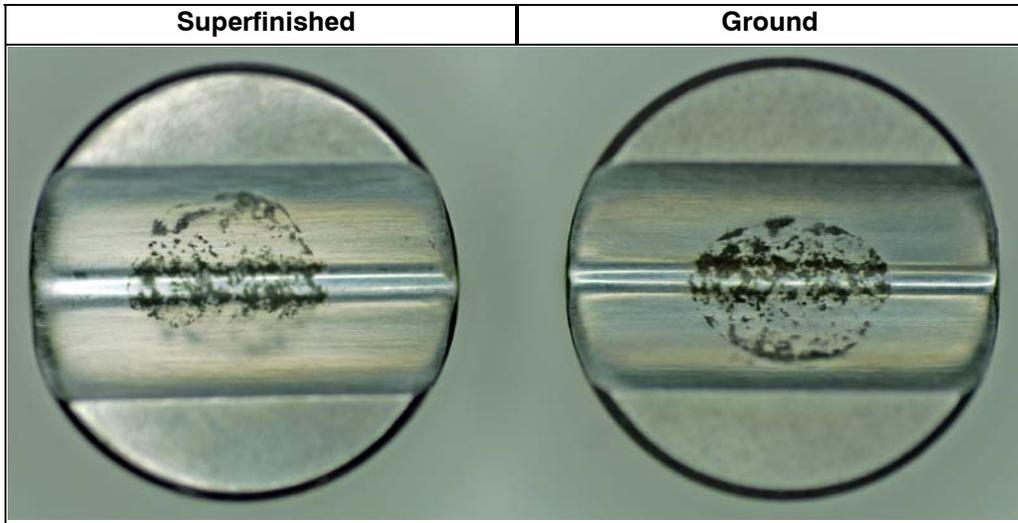
This layer was mechanically removed; the V-Block was polished with 1500-grit paper to remove the greater part of the corrosion deposits. The surface was then cleaned with #0000 steel wool followed by ultrasonic cleaning in a mild caustic cleaning solution. Pitting corrosion, crevice corrosion, and IGA were observed on both the superfinished surface and ground surface. See Figures 7 and 8.

Figure 7. View 3 - Superfinished (L) and ground (R) after mechanical cleaning, showing residual corrosion

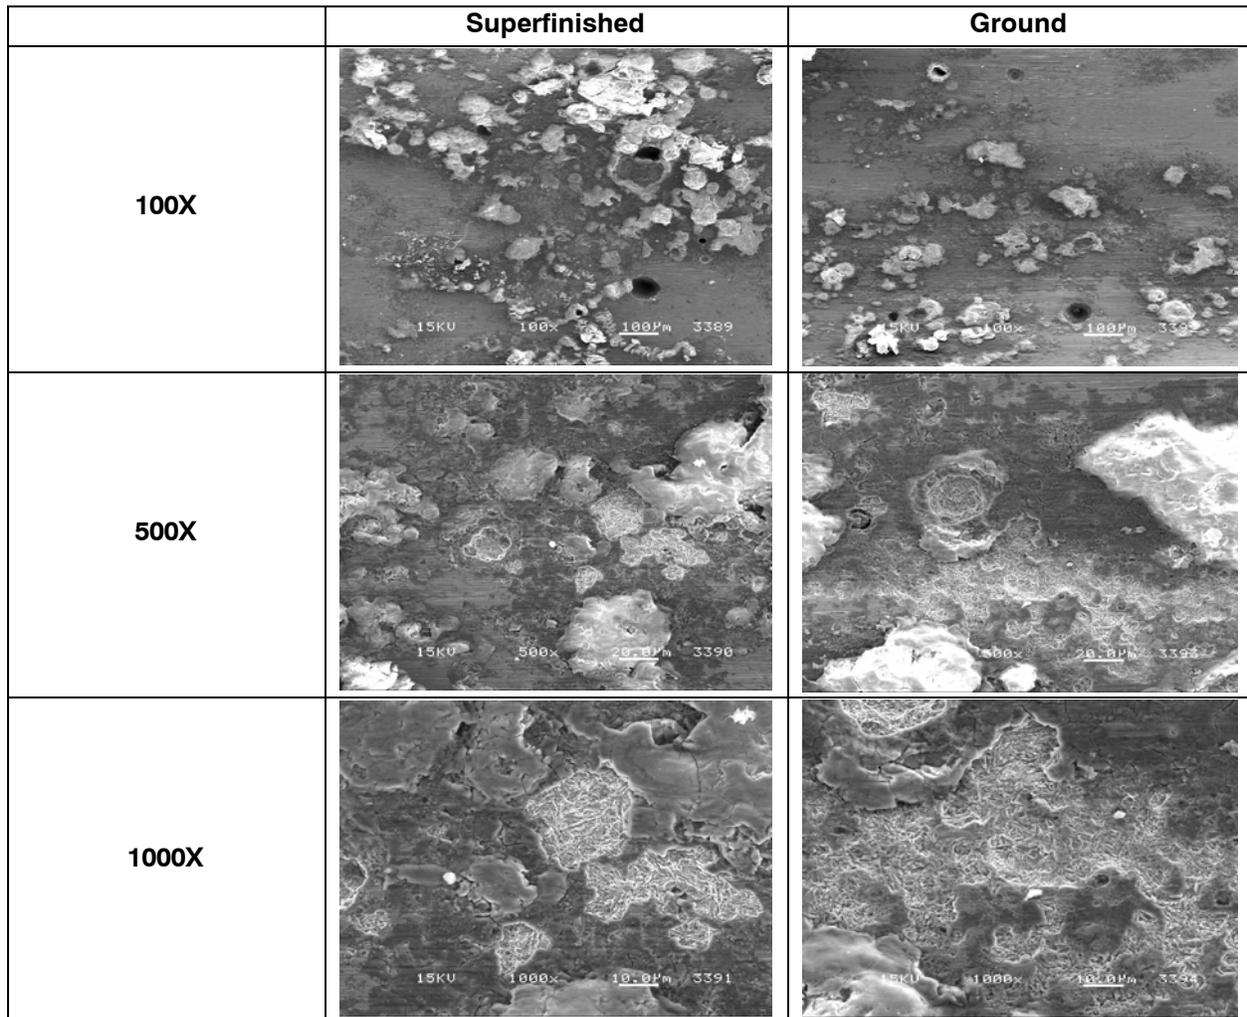
Figure 8. SEM images of test specimens after mechanical cleaning. Superfinished (L) and ground (R). Deep pits are visible in the 100X images. The white deposits cover shallower pits. IGA cracks are visible in the 1000X images.

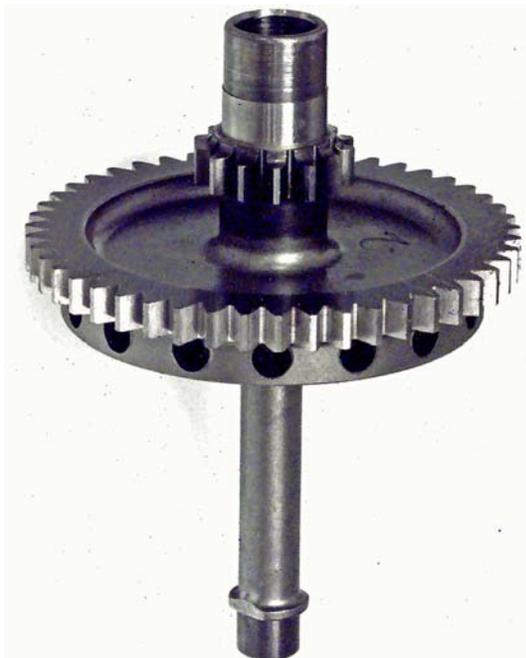
In 2000, Rolls-Royce Corporation sent used/scrap carburized AISI 9310 gasifier train gearshafts to REM Chemicals, Inc. for edge radiusing. See Figure 9. Initial inspection revealed light contact damage on the gear flanks.

Figure 9. As received used/scrap carburized AISI 9310 gasifier train gearshaft

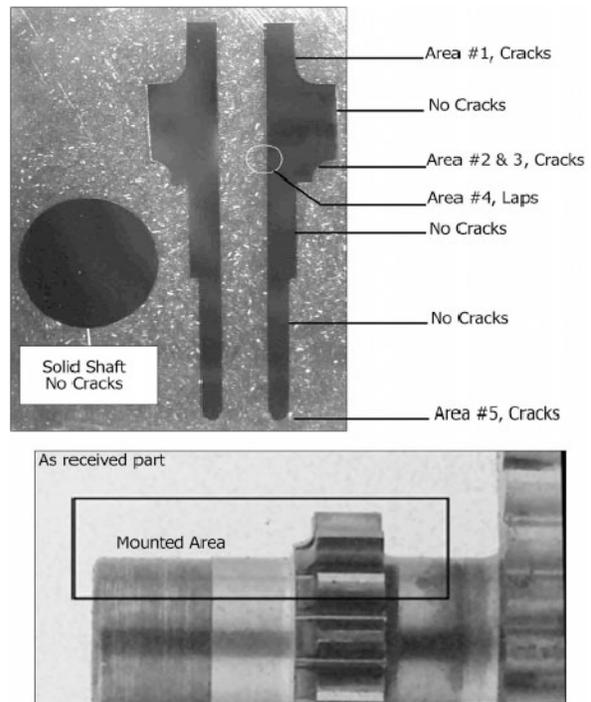
The superfinished gears were subjected to a rigorous inspection upon return to Rolls-Royce. Initially, it was assumed that the damage was caused by the superfinishing process, since it is carried out in a very weak acidic medium. REM conducted their own inspection at a metallurgical laboratory (Anderson & Associates, Houston, TX); the gear was sectioned, polished, and examined. IGA was detected, confirming Rolls-Royce's initial findings. Light contact fatigue damage was also detected by the laboratory. Figure 11 shows the sections and the target inspection areas. Photomicrographs of the various areas are shown in Figures 12-16.

Figure 11. Locations of IGA and contact damage on gearshaft sections (Top) taken from the gearshaft (Bottom)

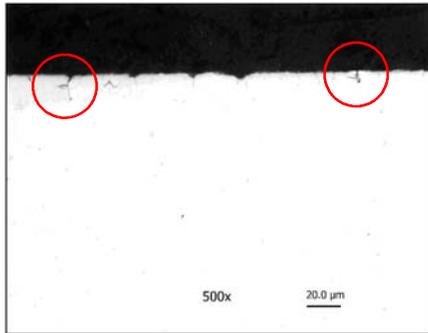
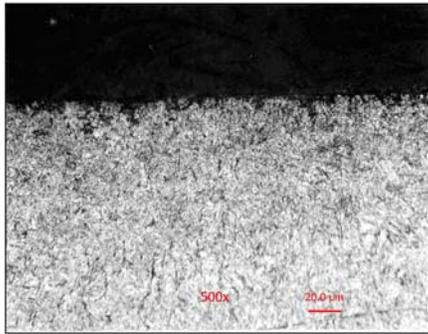
Figure 12. Photomicrographs of Area 1 at 500X magnification. Circles show several IGA cracks.

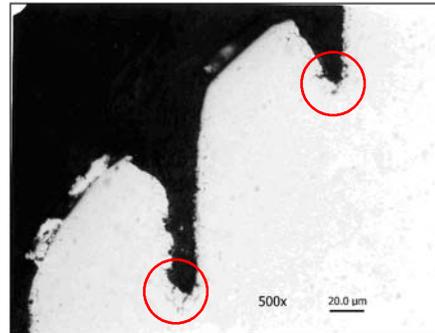
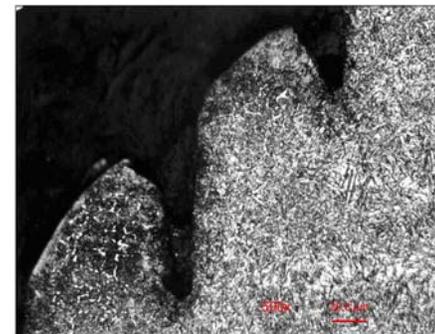
Figure 14. Photomicrograph of Area 3 at 500X magnification. Circles show visible IGA cracks in the valleys of the machining lines

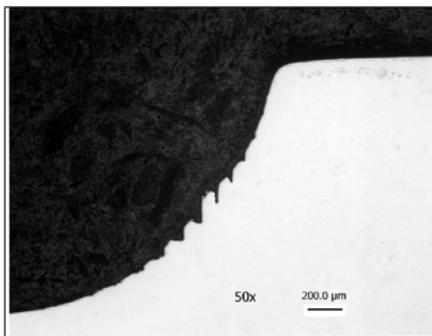
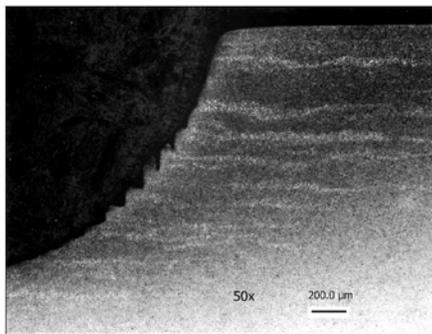
Figure 13. Photomicrographs of Area 2 at 50X magnification showing residual machining lines

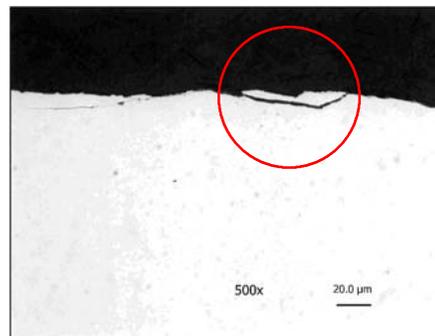
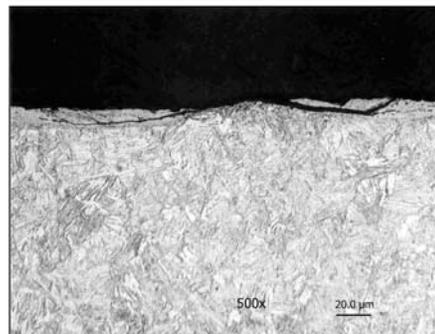
Figure 15. Photomicrograph of Area 4 at 500X magnification showing contact surface damage

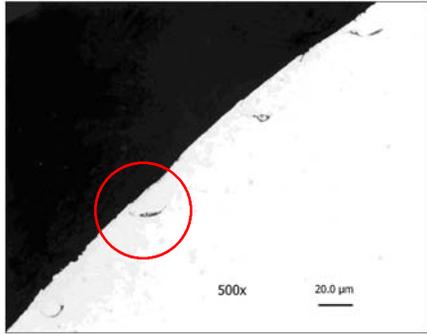
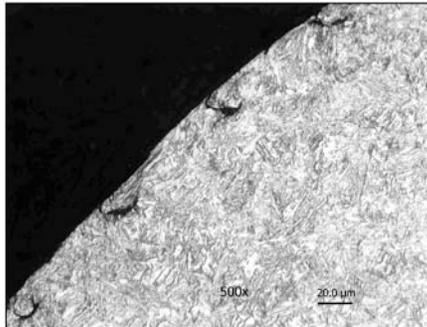
Figure 16. Photomicrograph of Area 5 at 500X magnification. Circle shows contact surface damage

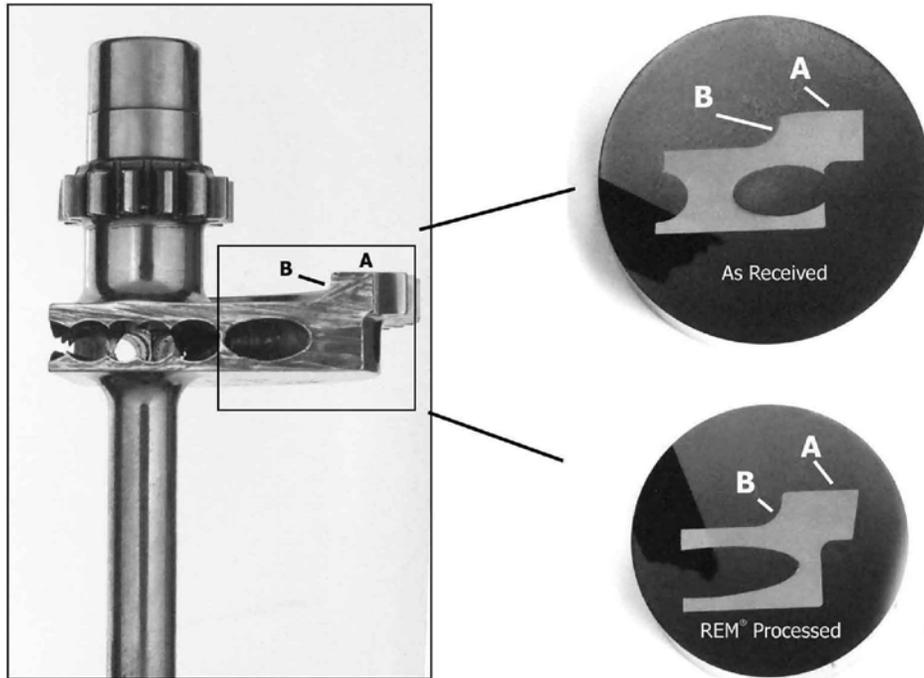
Figure 18. Cross section of gearshaft studied to determine the effect of superfinishing on IGA. IGA was detected on areas A & B

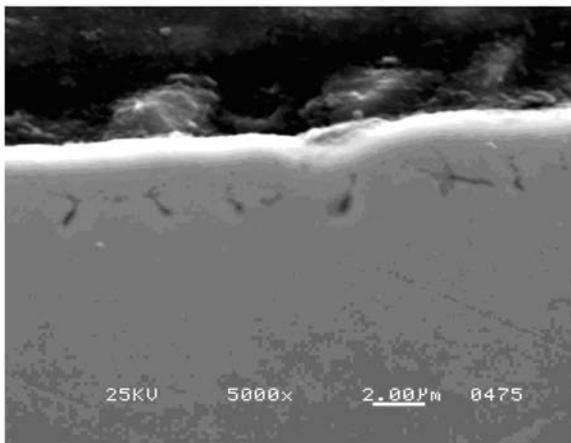
The gearshaft was sectioned, polished, and examined. SEM images confirmed the presence of IGA. See Figure 19. The maximum nominal depth of the IGA was 0.0002”.

Figure 19. SEM at 5000X magnification, showing the presence of IGA. Circle shows a typical IGA crack on areas A & B. The nominal IGA depth is 0.0002"

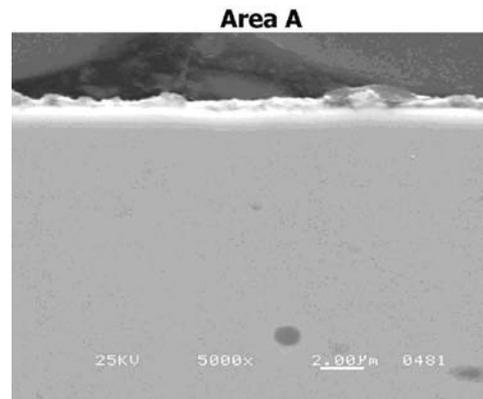
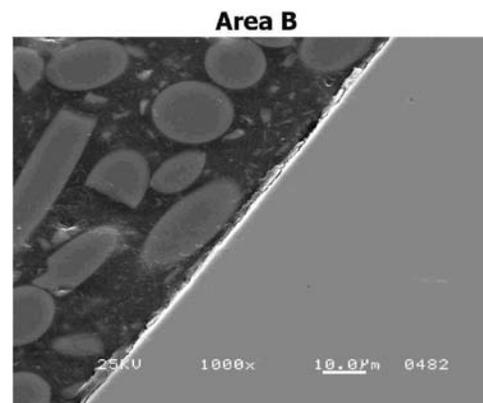
Figure 20. SEM images of Areas A and area B showing that superfinishing removed the IGA

The gearshaft was then superfinished such that approximately 0.0002” of metal stock was removed. It was then sectioned, polished, and examined for the final inspection. The SEM image clearly shows that the layer containing the IGA was completely removed. See Figure 20. The surface at 5000X shows that it is extremely smooth. This proved that the superfinishing process is not only metallurgically safe, but is also capable of repairing damaged surfaces. However, the depth of the damage must not exceed the metrological tolerance limits of the gear teeth.
