Gear Repair for Helicopters and Wind Turbines via Isotropic Superfinishing

Vincent Cline
Project Engineer II
REM Research Group
Brenham, TX, USA

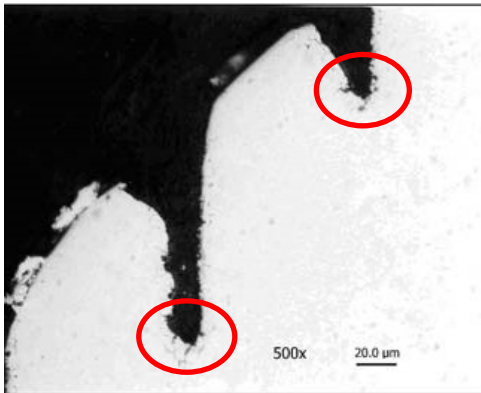
Fig. 1 Photomicrograph at 500X. Circles show visible IGA in the valleys of machining lines (Ref. 2).

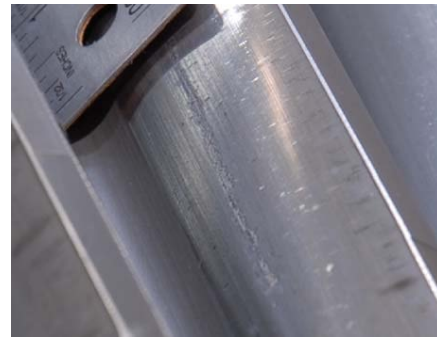
Fig. 15 Example of Micropitting on a Wind Turbine Sun Pinion

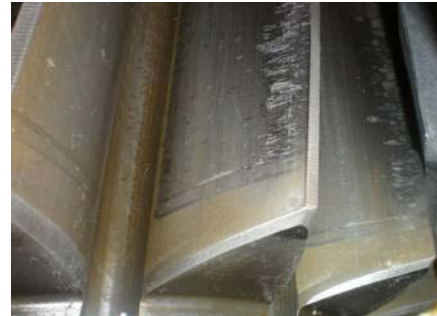
Fig. 16 Example of Scuffing on a Wind Turbine Intermediate Pinion

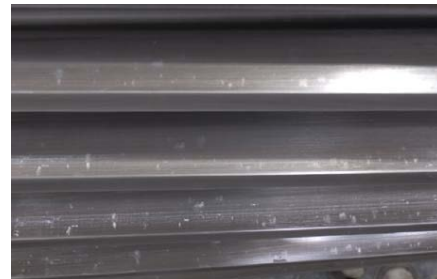
Fig. 17 Example of FOD Damage on a Wind Turbine Annulus Gear

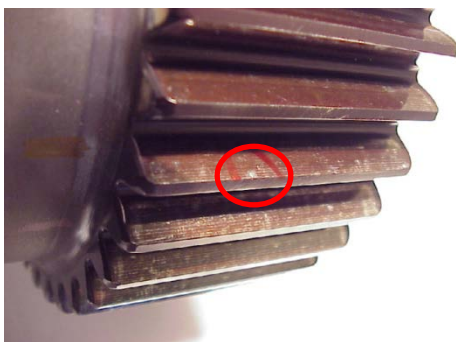
Fig. 18 Boeing CH-46 Sun Gear with identified FOD damage (Ref. 9)

The FOD damage illustrated in Fig. 18 was measured to have a depth of 0.00006 of an inch ($\sim 1.5 \mu\text{m}$), and in general, it was hypothesized that much of the damage caught by the scribe method would have a depth of less than 0.0002 of an inch ($\sim 5 \mu\text{m}$). Given the referenced ISF material removal rates, the complete repair of this damage

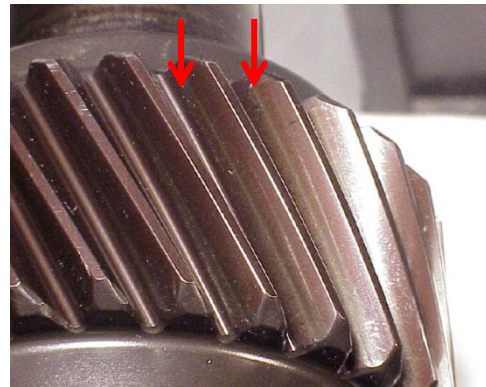
Fig. 19 Boeing CH-46 Input Pinion with identified micropitting below the pitch line (Ref. 9)

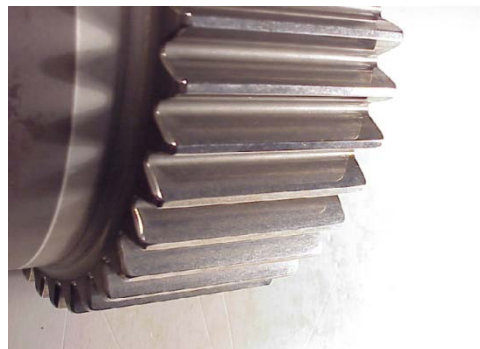
As noted in Appendix B, both components met spec after the noted damage was completely removed. One can see that the Input Pinion required more processing in order to remove all of the micropitting that was observed. Despite the additional material removal, all size changes were well within the design tolerances of the gear. Fig. 20 and Fig. 21 display the post ISF appearance of the two component types.

Fig. 20 Boeing CH-46 Sun Gear post ISF (Ref. 9)

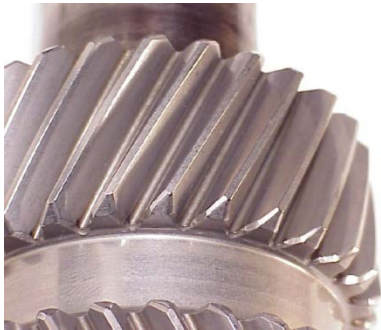
Fig. 21 Boeing CH-46 Input Pinion post ISF (Ref. 9)

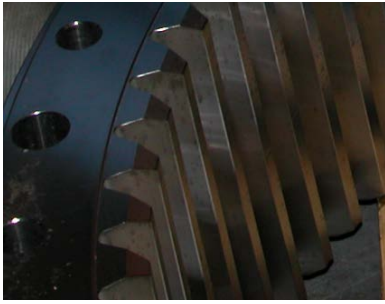
Fig. 30 Nitrided wind turbine annulus with mild flank damage

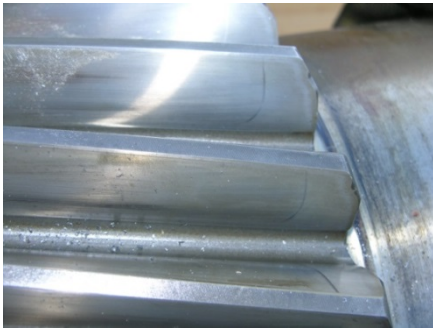
Fig. 38 Close-up of used, ground intermediate pinion – note light micropitting and defined edge contact pattern

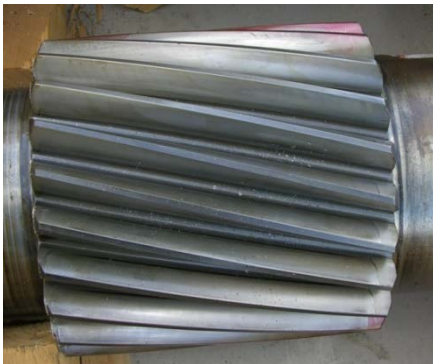
Fig. 39 Used, ground intermediate pinion

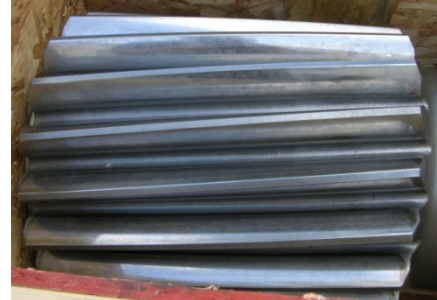
and the relatively low number of operating hours on the gearbox, this result is not surprising (see Fig. 40). However, two notable differences from what would be expected on a gear of this age for a fully isotropically finished component are: the evidence of a defined contact pattern edge and visually discernable roughness variations on the gear flank (see Fig. 41).

Fig. 40 Used, partial isotropic superfinish sun pinion

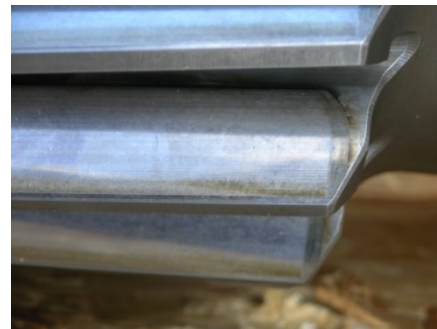
Fig. 41 Close-up of used, partial isotropic superfinish sun pinion – defined edge contact pattern

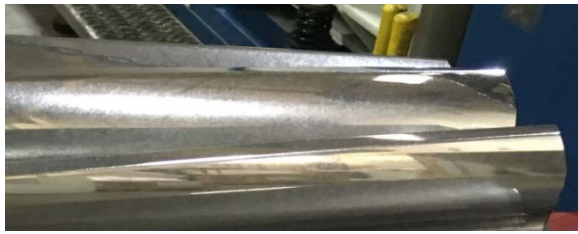
Fig. 42 and Fig. 43 show the post ISF repair condition of these two components. Note the complete removal of the contact pattern and the creation of full isotropic superfinishes on both components.

Fig. 42 Close-up of ISF repaired sun pinion

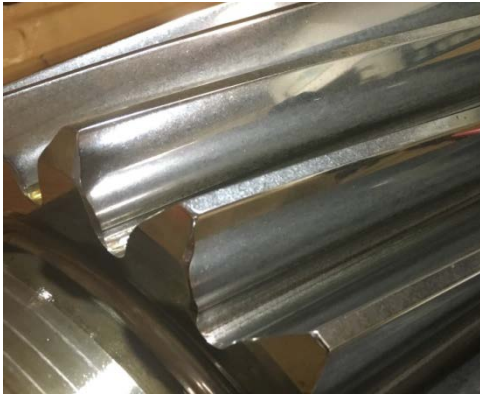
Fig. 43 Close-up of ISF repaired intermediate pinion

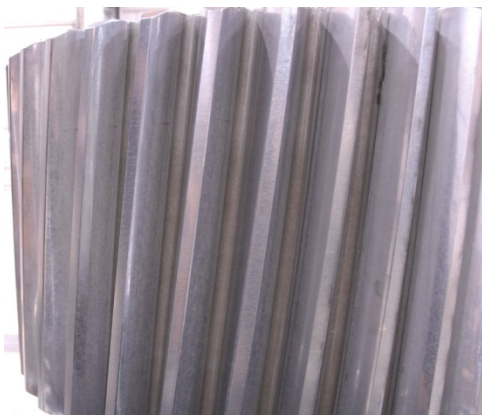
Fig. 44 Used, full isotropic superfinish planet gear

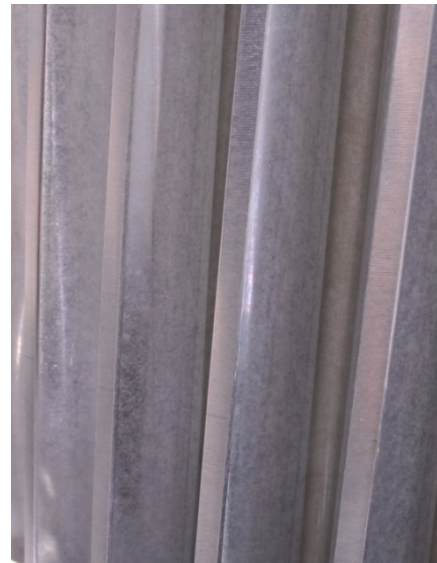
Fig. 45 Close-up of used, full isotropic superfinish planet gear
