Future Advanced Rotorcraft Drive System (FARDS) Full Scale Gearbox Demonstration

Andrea Chavez
Aerospace Engineer
Bell Helicopter, Textron
Fort Worth, Texas, USA

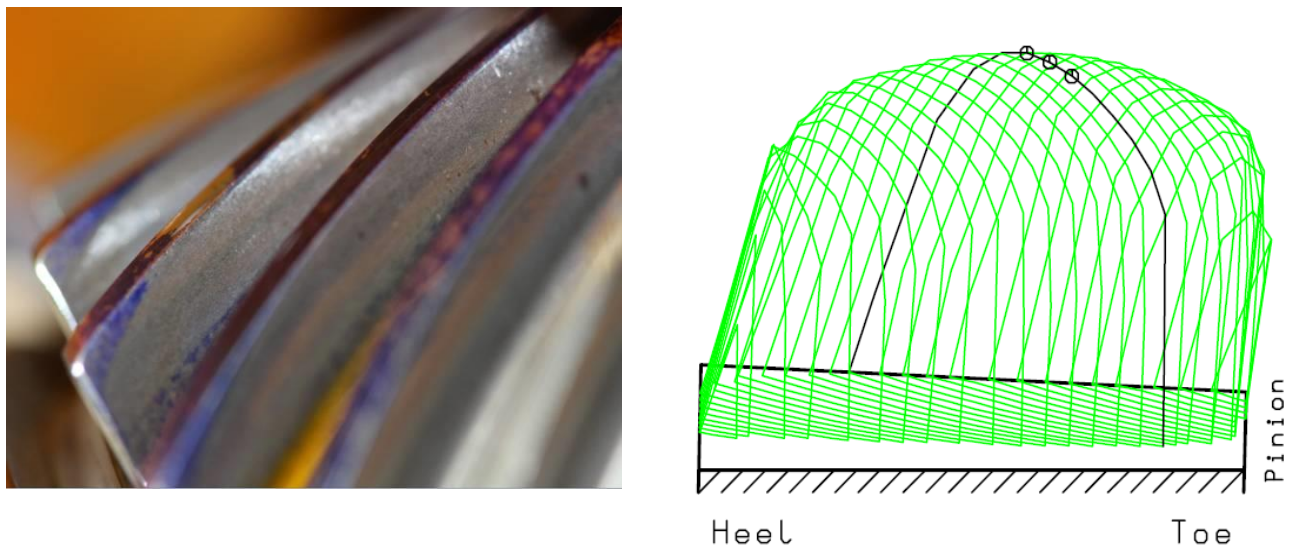
tooth loading analysis vs. the measured tooth contact pattern under load. Consistency between the two is confirmed in Figure 4. The third phase of testing included thermal testing of the gearbox internal components. These tests concentrated on verifying the performance of the gearbox and lubrication system under extreme conditions and allowed for further evaluation of component performance.

Figure 4. Input pinion gear tooth pattern for full speed and 100% torque.

Boroscope photo left, stress analysis of input pinion, right.

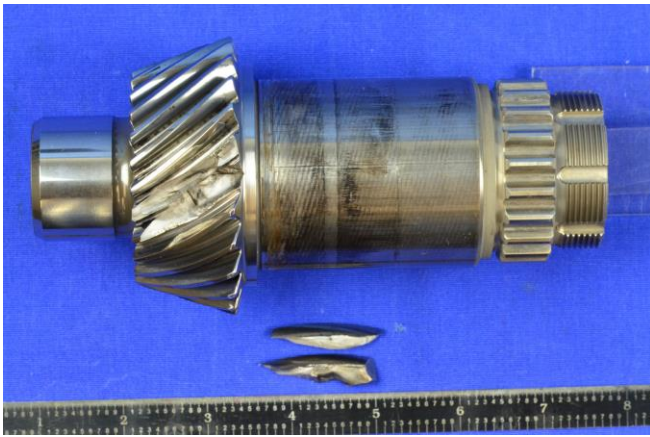
The test plan called for the gearbox to run for a total of 200 hours, but an input pinion failed at approximately 80 hours into the test (approximately 30 million cycles). Post-test evaluation of the input pinion indicated a fatigue failure in the input pinion with the origin of the failure at a subsurface inclusion. The primary fatigue fractured tooth is shown in Figure 7. Inspection of the other test components (apart from the input pinion) showed them to be in working condition with no signs of distress. No remaining spare input pinions were available to continue the test beyond the 80 hours, so endurance testing was stopped at this point. Although the gearbox did not complete endurance testing to 200 hours, it was believed that all the other components would have been able to complete the 200 hours of testing without failure because of the working condition after 80 hours testing (and therefore did not affect the individual TRL levels).

Figure 7. Input pinion failure in the endurance test.

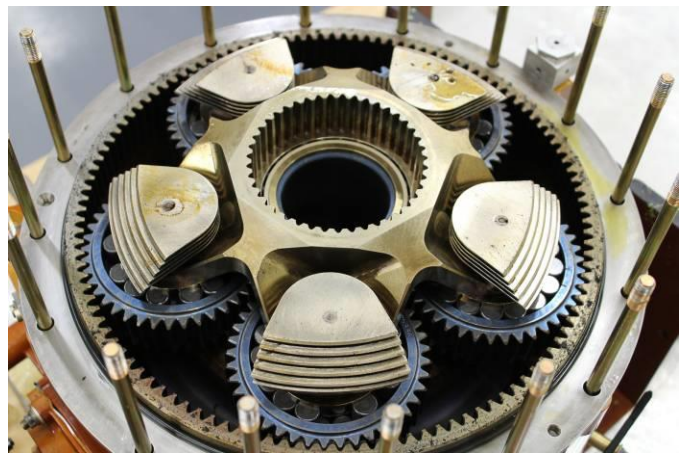
Upon cool down, the gearbox was inspected in the test stand. The input shaft and the main rotor mast had apparently seized. Disassembly was necessary to inspect gears and bearings. Post-test pictures for comparison are given in Figures 8-12, where the condition of the components within the gearbox immediately after testing are shown. For comparison purposes, similar gearbox post-test pictures are shown for all three loss-of-lubrication tests. Figure 8 shows the FARDS MRGB after the top case has been removed, exposing the condition of the heat pipes and the planetary assembly. With the planetary assembly removed, Figure 9 displays the condition of the gearshaft. It was evident that the PEEK bearing cages were melted within the planetary assembly. During cool-off, the melted PEEK remnants within the box re-hardened around many of the components. Melted PEEK in the gearbox was the reason behind the seized input shaft. Figure 10 shows the bottom of the case with PEEK remnants. The gearshaft roller bearing cage made of PEEK melted. When the gearshaft was removed from the case, the rollers dropped from position, as seen in Figure 11. Magnetic Particle Inspection (MPI) revealed that although the gear teeth were showing signs scuffing and discoloration, they were no signs of surface damage or cracks given the temperatures endured during testing. An example of the input pinion discoloration and scuffing is shown in Figure 12.

Figure 8. FARDS MRGB LOL with PEEK bearing cages – top case removed.

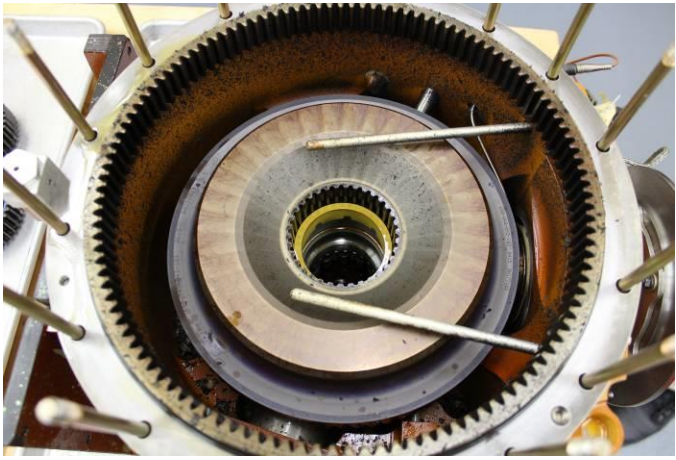
Figure 9. FARDS MRGB LOL with PEEK bearing cages – planetary assembly removed.

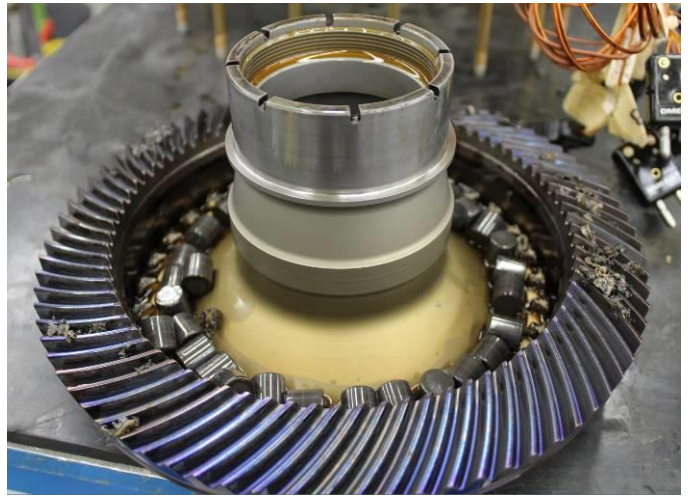
Figure 11. FARDS MRGB LOL with PEEK bearing cages – gearshaft.

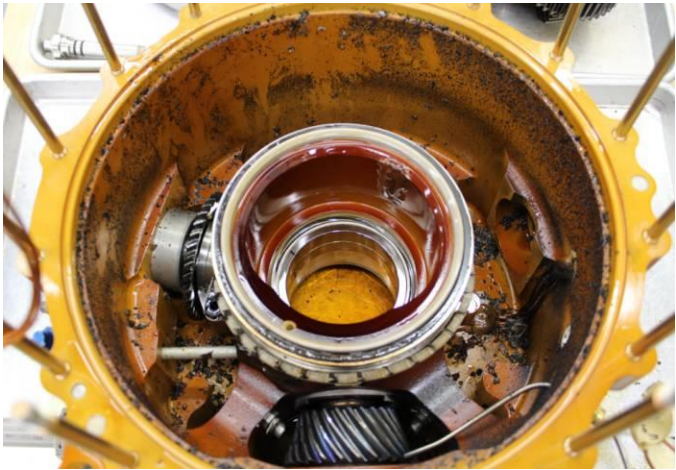
Figure 10. FARDS MRGB LOL with PEEK bearing cages – bottom of case.

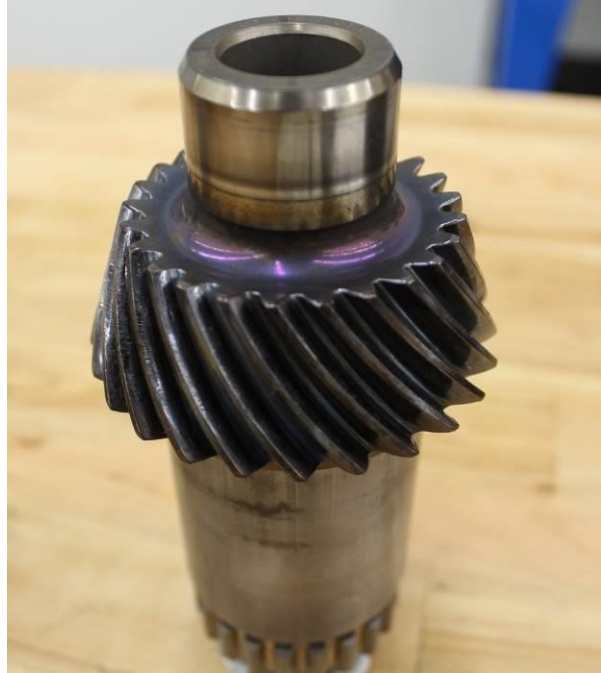
Figure 12. FARDS MRGB LOL with PEEK bearing cages – input pinion.

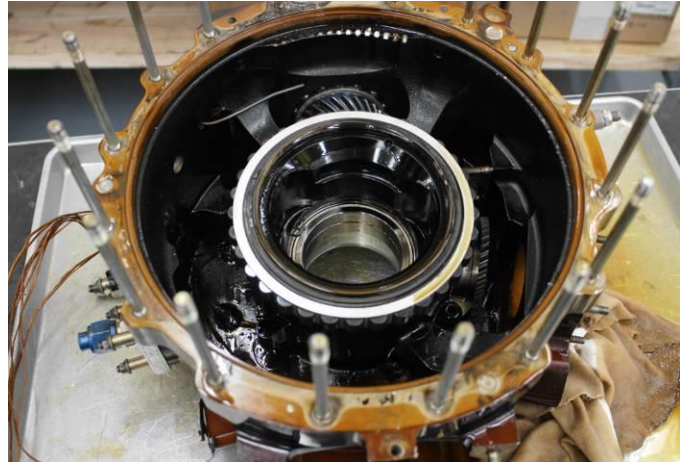
Figure 15. FARDS MRGB LOL with steel bearing cages – bottom of case.

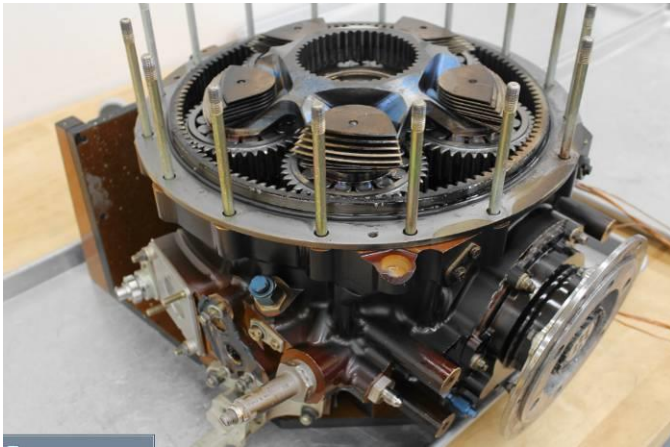
the gears and bearings were in good condition. Post-test pictures in Figures 13-17 show the condition of the components within the gearbox immediately after testing. Figure 13 shows the FARDS MRGB after the top case has been removed, exposing the condition of the heat pipes and the planetary assembly. Both the heat pipes and the planetary did not show signs of distress. With the planetary assembly removed, Figure 14 displays the condition of the gearshaft, which also showed no sign of distress. Figure 15 shows internal case discoloration due to heat during testing. Figures 16 and 17 show the input pinion with moderate scuffing. The scuffing found on the gear teeth show explains the temperature rise found during testing.

Figure 13. FARDS MRGB LOL with steel bearing cages – top case removed.

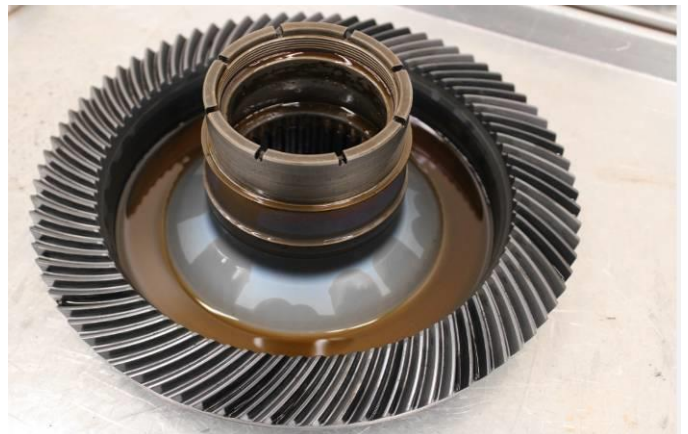
Figure 16. FARDS MRGB LOL with steel bearing cages – gearshaft.

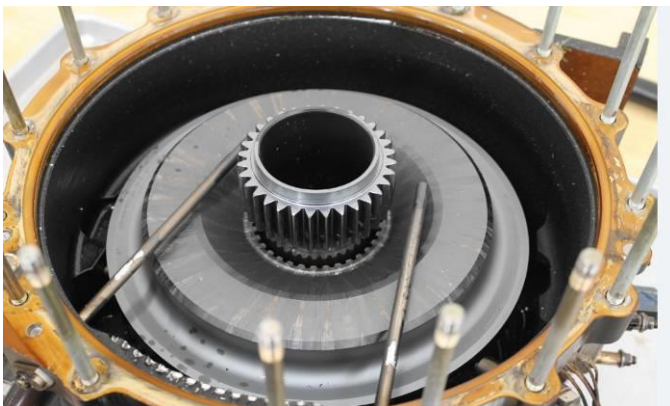
Figure 14. FARDS MRGB LOL with steel bearing cages – planetary assembly removed.

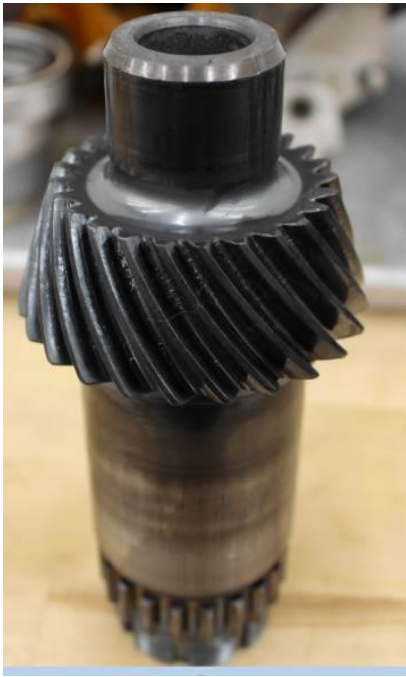
Figure 17. FARDS MRGB LOL with steel bearing cages – input pinion.

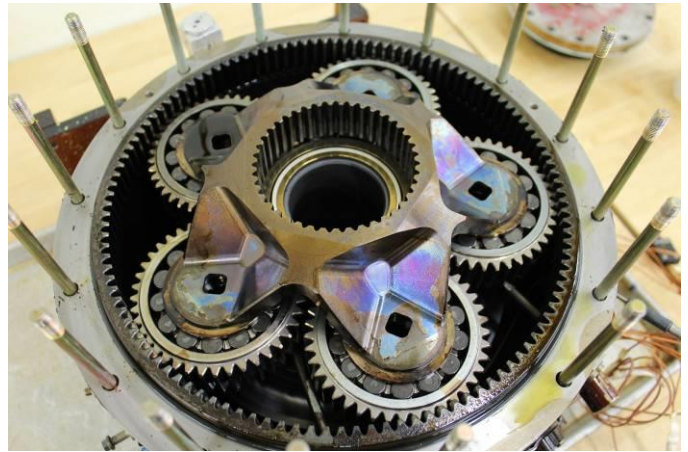
Figure 18. FARDS MRGB LOL without heat pipes and steel bearing cages – top case removed.

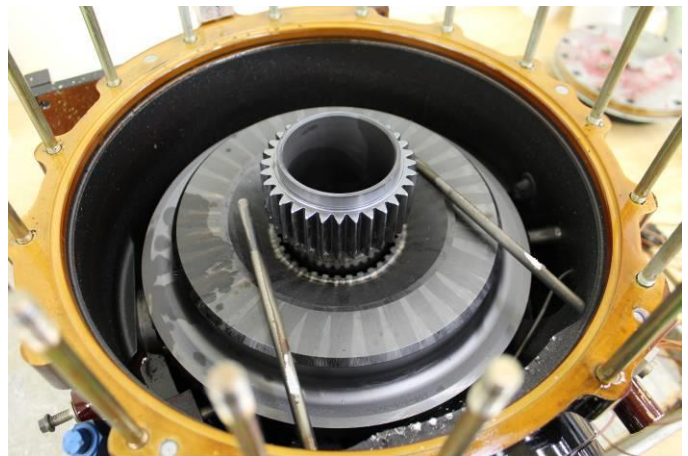
Figure 19. FARDS MRGB LOL without heat pipes and steel bearing cages – planetary assembly removed.

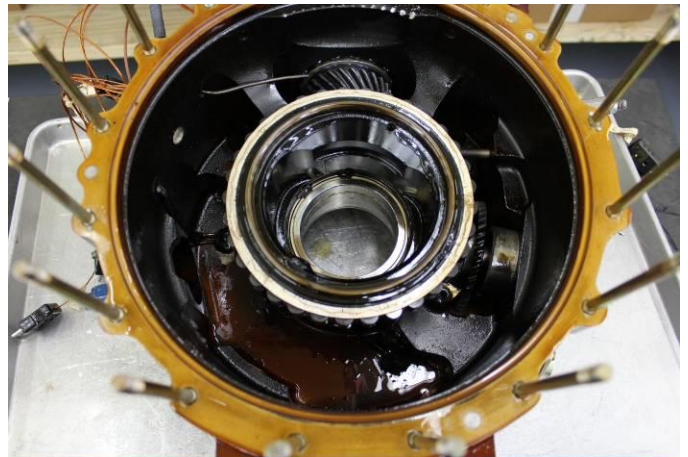
The final loss of lube test evaluated the gearbox with steel bearing cages and eliminated the heat pipes. After approximately 85 minutes of testing, similar to the previous LOL test, the temperatures observed from the spiral bevel gear-mesh fling-off were increasing at a faster rate to indicate imminent failure. The test stand was shut down. Figures 18-22 show the condition of the components within the gearbox immediately after testing. Figure 18 shows the FARDS MRGB after the top case has been removed, exposing the condition of the heat pipes and the planetary assembly. With the planetary assembly removed, Figure 19 displays the condition of the gearshaft. Figure 20 shows internal case discoloration due to heat during testing. Figure 22 show scuffing on the input pinion gear teeth.

Figure 20. FARDS MRGB LOL without heat pipes and steel bearing cages – bottom of case.

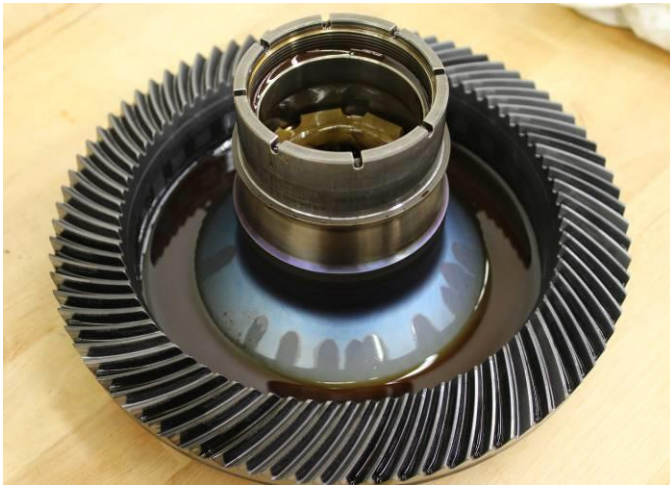
Figure 21. FARDS MRGB LOL without heat pipes and steel bearing cages – gearshaft.

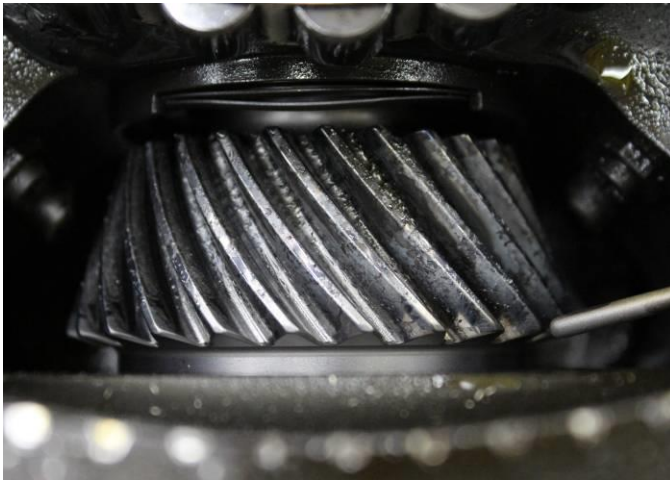
Figure 22. FARDS MRGB LOL without heat pipes and steel bearing cages – input pinion.
