## Feature - SUPERFINISHING

# Repairing wind turbine gears and assemblies with isotropic superfinishing

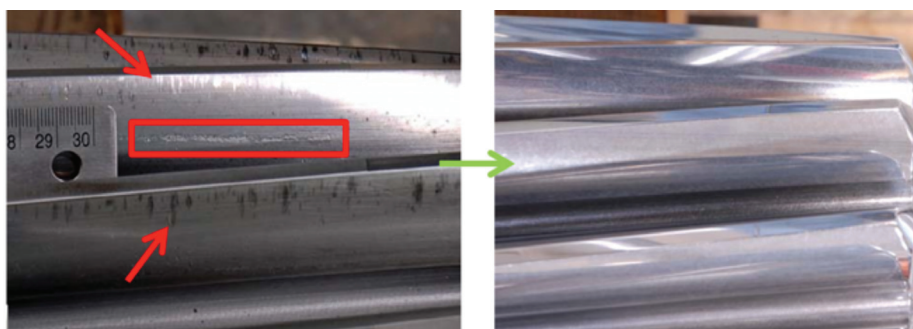
The first case study is of an early design, ground sun pinion, which only operated for roughly three years prior to requiring refurbishment. Visual inspection showed multiple forms of damage including abrasion, corrosion, micropitting and FOD damage. This pinion was able to be fully repaired and returned to service with an improved isotropic superfinish on its gear flanks.

Damaged, ground sun pinion (left), the same sun pinion after isotropic superfinishing (right)
