WIND TURBINE GEAR REPAIR

Due to the large installed base of wind turbines, demand for gearbox repairs has risen steadily in recent years. Isotropic superfinishing is an ideal process for repairing damaged gear flanks and bearing surfaces found on used wind turbine gears.

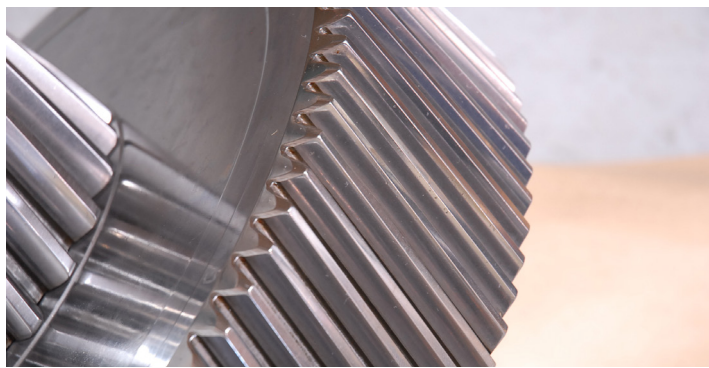
A growing preference in the repair industry is to use isotropic superfinishing to repair damaged wind turbine gears. This surface engineering technique, described in the October 2015 Materials Matter article, “Isotropic Superfinishing,” can repair all of the typical types of damage found in modern wind turbine gearboxes. It is ideal for handling the low volumes and multiple gear types found in a typical repair job due to its process flexibility. Moreover, isotropic superfinishing does not require gear engineering drawings and carries none of the scrapping risks associated with regrinding. Chemically accelerated isotropic superfinishing processes, such as those used by REM Surface Engineering, are approved for use on nitrided components. These chemically accelerated isotropic superfinishing processes are also capable of repairing assemblies, eliminating the need to disassemble/reassemble or scrap the components. Figure 1 shows an intermediate assembly after it has undergone an isotropic superfinishing repair process.

Figure 1: Used intermediate assembly after isotropic superfinishing
