08FTM18

Gear Corrosion During the Manufacturing Process

By O. El-Saeed and G. Sroka,
REM Chemicals, Inc. and
G. Blake, Rolls-Royce
Corporation

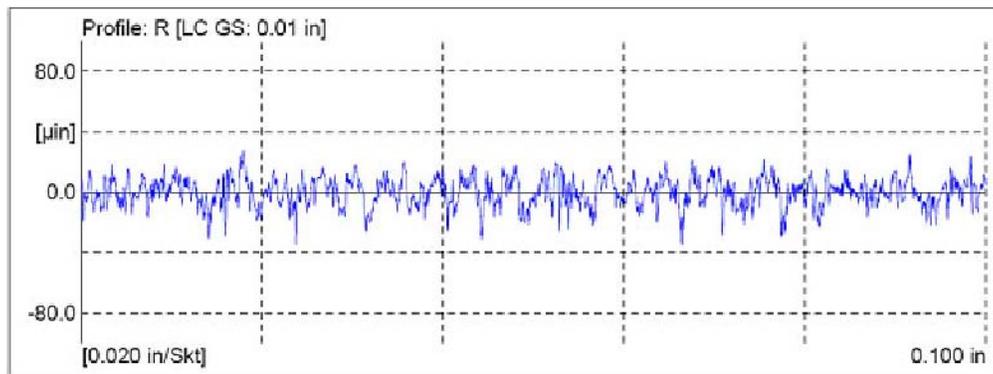
Figure 3. Surface profile of the ground V-Block

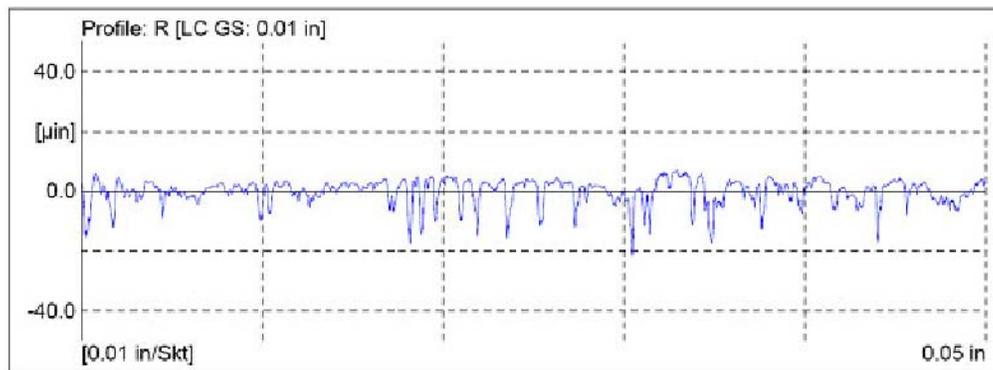
Figure 4. Surface profile of the superfinished Falex V-Block

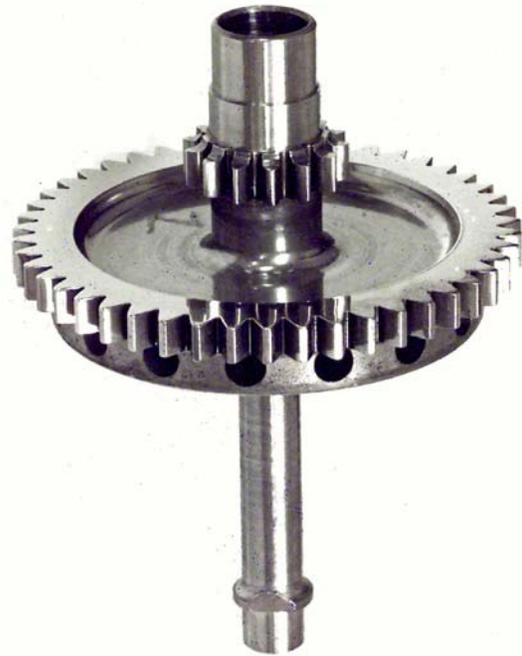
The gearshaft was superfinished using chemically accelerated vibratory finishing, as described elsewhere.[5] [6] See Figure 10.

Figure 10. Superfinished used/scrap carburized AISI 9310 gasifier train gearshaft

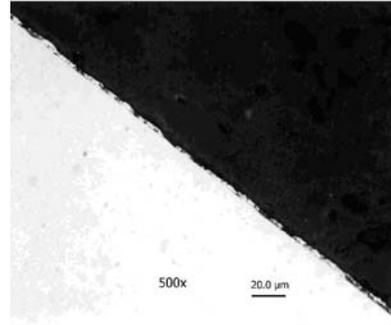
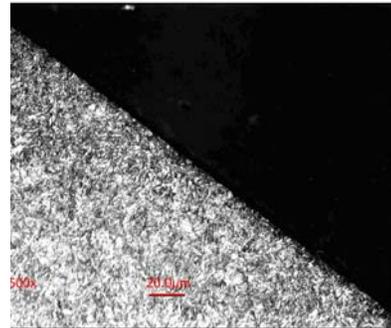
In order to demonstrate that the superfinishing process did not cause IGA, a Falex 9310 V-Block was superfinished under the same conditions as the AISI 9310 gearshaft. The V-Block was sectioned, polished and the V-area was examined. The photomicrographs showed no IGA or pitting. See Figure 17. This definitively confirmed that superfinishing does not induce IGA.

Figure 17. Photomicrograph of the V-Area of the superfinished V-Block at 500X magnification. No pitting or IGA was detected.
